# Nurse AdviseERR®

## Saline infusions and flush syringes may not be as “harmless” as you think – scanning will help

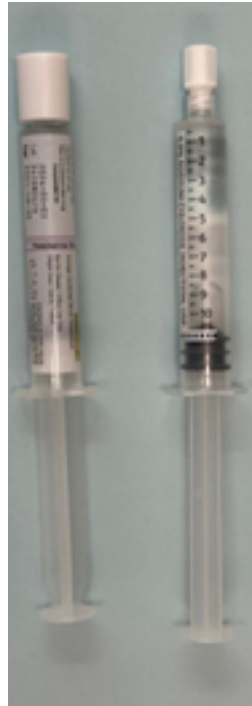
In a report we received, a nurse removed what she thought was a 10 mL 0.9% sodium chloride flush from a tray in the patient’s room, then almost gave it during a bedside procedure. Before administration, the nurse read the label and identified that the syringe contained phenylephrine 1,000 mcg/10 mL instead of saline. The prescriber ordered the phenylephrine to be stored at the bedside in case the patient experienced hypotension during the procedure. The hospital had purchased the phenylephrine syringe from STAQ Pharma, a 503B outsourcing facility. The hospital reported that the phenylephrine syringe which previously had a red cap, now has a white cap, similar to the sodium chloride flush syringes (BD) (**Figure 1**). STAQ Pharma told the hospital that they changed the phenylephrine cap color from

**Figure 1.** Instead of a 0.9% sodium chloride flush (right, BD), a nurse nearly administered phenylephrine 1,000 mcg/10 mL (left, STAQ Pharma), packaged in a similar-looking syringe that was kept at the bedside prior to a procedure.

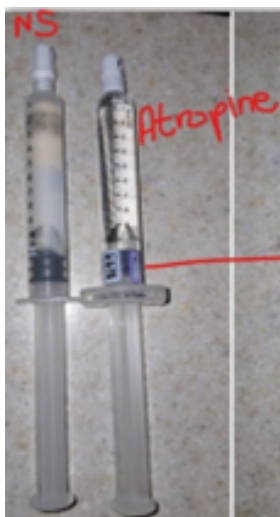
In another case, a hospital recently procured atropine sulfate injection 1 mg/10 mL syringes manufactured by Amneal. A nurse contacted the pharmacy to report that the atropine syringes were nearly indistinguishable from the 0.9% sodium chloride flush syringes made by BD (Figure 2). The nurse noted that these atropine syringes do not come with an overwrap like their previously purchased atropine product, and the labels and printing on the syringe were incredibly small, making it difficult to identify the contents.

**Figure 2.** The 0.9% sodium chloride flush syringe by BD (left) looks similar to the atropine syringe by Amneal (right).

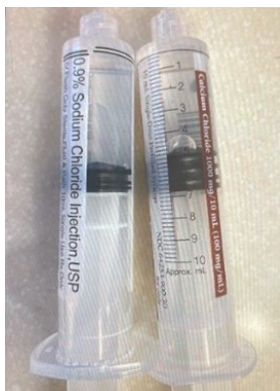
In yet another case, a hospital reported that once a practitioner removes the overwrap, sodium chloride 0.9% flush syringes (Excelsior Medical) look very similar to calcium chloride 1,000 mg/10 mL syringes (Medefil) (Figure 3). This led to a close call in an operating room where barcode scanning has not been implemented.

**Figure 3.** The 0.9% sodium chloride flush syringe by Excelsior Medical (left) looks like the calcium chloride syringe by Medefil (right), once removed from their overwraps.

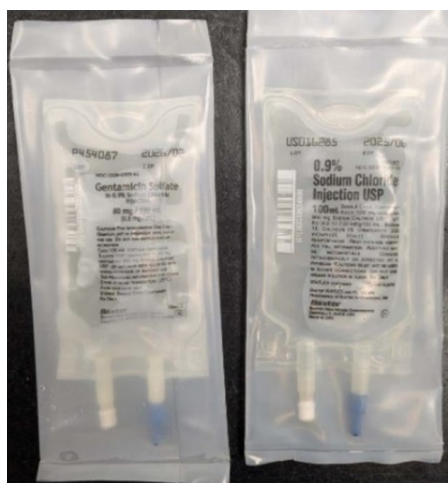
Errors and close calls can also occur with premixed saline infusions. In a recent case, a radiology technologist removed a 100 mL bag of what he thought was 0.9% sodium chloride from a bin in the imaging center. When loading the fluid into the computed tomography (CT) contrast power injector, the technologist noticed the label looked different than the one on the bag he typically used. He did not administer the fluid and immediately brought the bag to the pharmacy. The pharmacist identified that it was gentamicin 80 mg/100 mL in 0.9% sodium chloride injection. The pharmacist called the imaging center and asked the nurse to check the bin where the 100 mL saline bags were stored. She found additional bags of gentamicin, which were sequestered. Baxter makes both products, and they come in similar packaging (Figure 4).

**Figure 4.** Bags of gentamicin 80 mg/100 mL injection (left) were found mixed in the bin used to store bags of 0.9% sodium chloride 100 mL injection (right).

radiology technologist did not read the label or scan the barcode before restocking the bags, then unknowingly added the gentamicin bags to the 0.9% sodium chloride bin.

**Restrict medication purchasing.** Review medication and fluid (including saline fluids and flush syringes) ordering policies and procedures for all organizational locations (e.g., radiology, perioperative areas, outpatient infusion centers), including those purchased by non-pharmacy departments. Ensure medications are restricted to pharmacy purchasing unless an exception is specifically justified.

**Maximize barcode scanning.** Use barcode scanning when receiving, dispensing, filling the ADC or other storage location, and prior to administering any medication, including sodium chloride infusions and flush syringes. The ISMP [Targeted Medication Safety Best Practices for Hospitals](#), Best Practice 18, calls for maximizing the use of BCMA by expanding use beyond inpatient care areas, including perioperative areas, radiology, and the emergency department. Regularly observe scanning practices and review scanning data (e.g., compliance, alerts) to identify products commonly administered without scanning to help uncover potential workflow or product issues. Supervisors should be on constant lookout for staff who bypass this important safety system; gather feedback from end users about barriers to scanning (e.g., access to equipment) and solutions to address them.

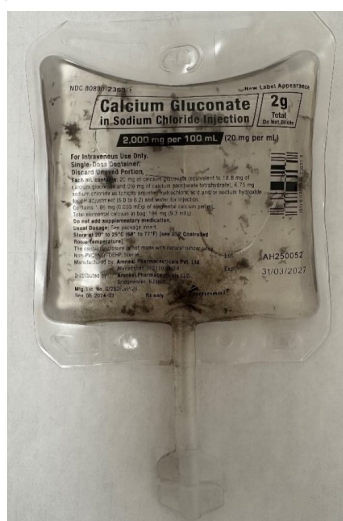
A hospital reported sterility concerns with a calcium gluconate 2,000 mg/100 mL injection bag manufactured by Amneal (NDC 80830-2363-1, lot number AH250052, expiration date 3/31/2027). A nurse went to remove a patient's dose from the automated dispensing cabinet (ADC) and, upon removing the overwrap, observed a black/brown substance resembling mold inside the sealed, unopened inner bag (**Figure 1**). The nurse never spiked or administered the product. It was immediately sequestered and reported to the pharmacy. The pharmacy removed the entire supply of 2,000 mg/100 mL calcium gluconate bags by Amneal from patient care areas.

**Figure 1.** A black/brown substance was found inside a sealed, unopened bag of calcium gluconate 2,000 mg/100 mL manufactured by Amneal.

We have reported this issue to FDA and Amneal. At this point, we do not know if this is the same issue as the WG Critical Care bags. These incidents underscore how critical it is for end users to stay vigilant in reviewing product integrity and to escalate potential safety issues. If your organization purchases calcium gluconate 2,000 mg/100 mL from Amneal or WG Critical Care, review your inventory and ensure end users are aware of this concern. If potentially impacted product is found, sequester it and report it to the manufacturer, FDA, and [ISMP](https://www.ismp.org). Remind staff to visually inspect all medication injectable solutions for particulate matter, discoloration, and potential contaminants prior to use.
